PERFORMANCE OF SEISMICALLY ISOLATED BUILDINGS IN JAPAN
-Observed records and vibration perception by people in buildings with seismic isolation -

N. Kani,¹ M. Takayama² and A. Wada³

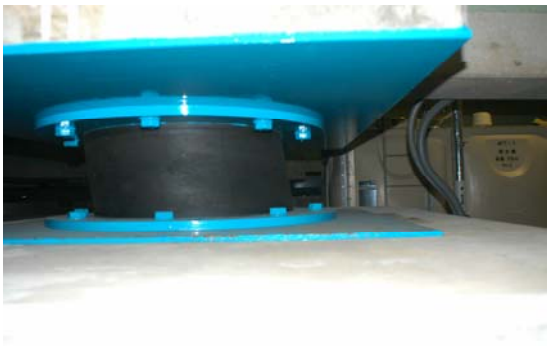
Photograph 2.1 Deformed elastomeric isolator.

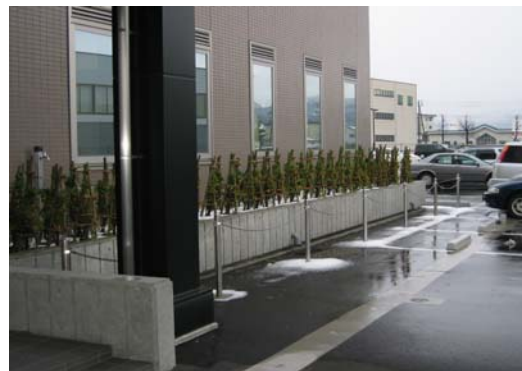
Photograph 2.3 NS computer

Some of the workers stayed there for a couple of days, using it as a shelter. It is a heavy snowfall area, and structural engineers must design to withstand at least 2.5 m of snow. Well water is used to melt snow in the perimeter zone to provide a secure clearance for the seismic isolation layer. Clearance is secured for the movement of the building (Photograph 2.3).⁴⁾

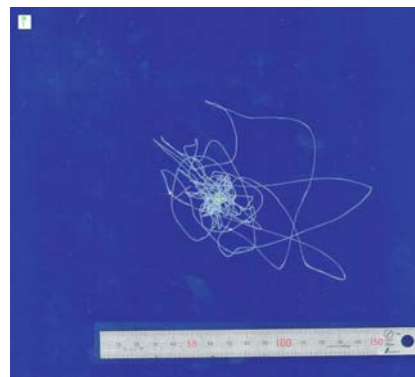
In addition, the server rack of the computer system was attached to the access floor by screws only, in accordance to low response acceleration by adoption of seismic isolation system. The relative displacement of seismic layer in the earthquake was about 80 mm by orbiter, shown in Photograph 2.4. There was no damage. Figure 2.1 shows the records of acceleration at K-NET NIG017 Nagaoka, 2.8 km from this building.

Photograph 2.4 Orbiter maximum displacement 80 mm.

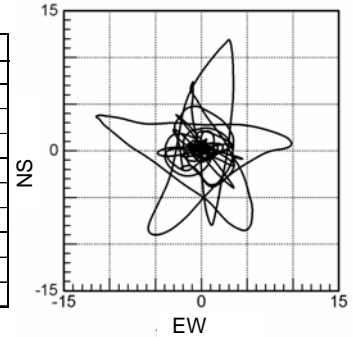
Figure 2.2 Trace of the movement.

They are very satisfied with the seismic isolation system in their building. About 200 mm displacement of seismic isolation layer was measured shown as Figure 2.2. The effect of seismic isolation is shown as one-fourth reduction by an installed seismograph installed in the seismic isolation layer as shown in Figure 2.3, 2.4 and Table 2.2.⁵⁾

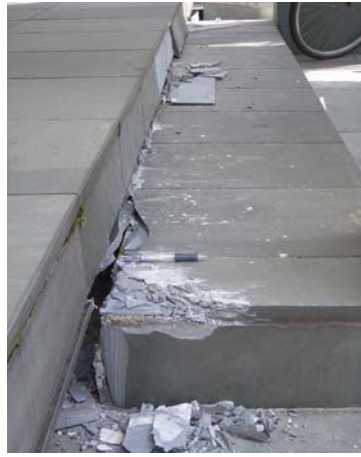
The building is in the vicinity of the Kego Fault. Photograph 3.1 shows the appearance of the building after the earthquake. The entrance step was partially damaged because of insufficient vertical clearance in Photograph 3.2. Conventional structures suffered damages in this area. In addition, the orbit was traced on the iron plate at the corner of the service entrance of the building (Photograph 3.3).

Photograph 3.2 Damage around the entrance.

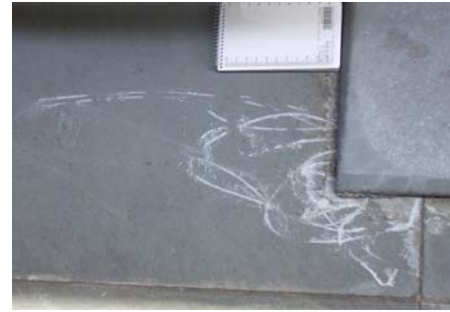
The north and south component was greater than east-to-west. The maximum response displacement of the seismic isolation layer reached about 300 mm. A seismograph was installed in this building; acceleration indicated 203 gal of NS component at 65 m below ground, 489 gal at base, and 234 gal at the top floor of the building.

Photograph 3.3 Trace of the movement.

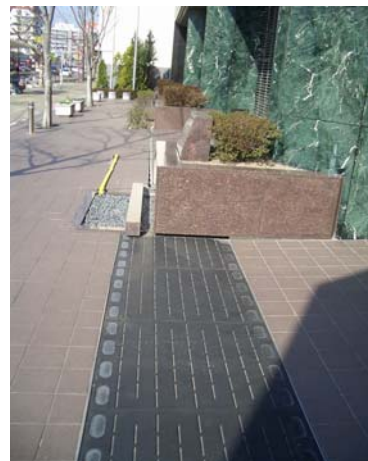
Photograph 3.5 of the entrance shows that curb stones had moved about 150 mm to the south. It is a good correspondence that the observed displacement was 145 mm shown as Figure 3.1. Acceleration of the superstructure was reduced to one-half to one-third in Figure 3.2 and Table 3.2.

Photograph 3.5 Entrance approach.

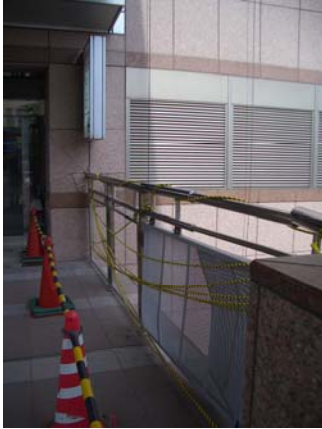
Photograph 3.6 shows the building appearance of a large-scale hospital. The entrance bridge of the south side of the hospital has expansion joints, but the handrail part of it did not work well as shown in Photograph 3.7.

Photograph 3.7 Expansion joint of the bridge.

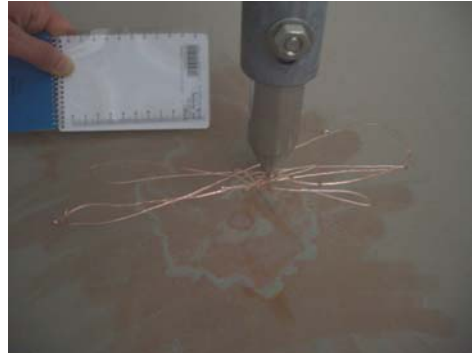
Wall cracks occurred in adjacent conventional structures. Photograph 3.8 shows the trace with an orbiter installed in the seismic isolation layer. As for the displacement of the seismic isolation layer, the north-south axis is bigger than the east-west one; it was about 150 mm. A repetition of almost 2 cycles was traced at the maximum.

Photograph 3.8 Orbit in seismic isolation layer.

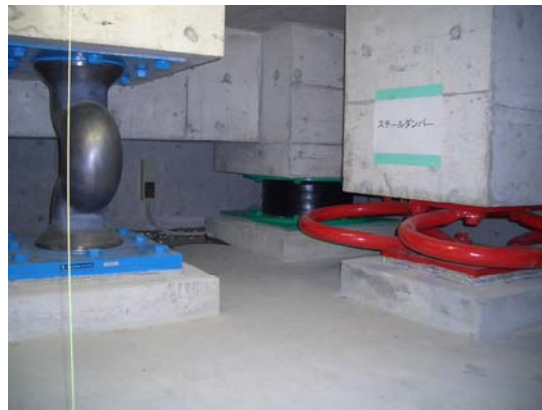
According to a hotel clerk, his perception was that the vibration was slow during the earthquake. There were ten guests there at the time of the earthquake, but they did not express any fear about shaking of the building. The elevators stopped for about five minutes, but resumed automatically, and nothing fell down or moved. There was no residual deformation in the seismic isolation devices according to the plumb-bobs in Photograph 3.10.

Photograph 3.10 Devices of the hotel
