RECONNAISSANCE REPORT OF THE 2008 SICHUAN EARTHQUAKE, DAMAGE SURVEY OF BUILDINGS AND RETROFIT OPTIONS

H.K. Miyamoto^{1,2}, and A.S. Gilani¹ and Akira Wada²
H.K. Miyamoto, A.S. Gilani, 和田章

¹ *Miyamoto International Structural and earthquake Engineers, USA*

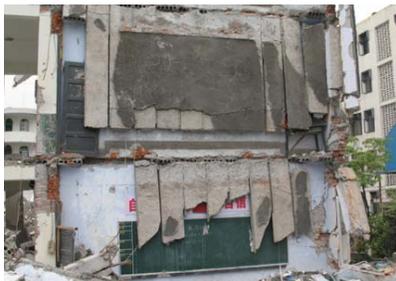
This three-story school is in Juyuan, a town in the county-level city of Dujiangyan. Juyuan has a population greater than 50000 and is approximately 20 kilometers from the fault rupture. The school housed 1000 students and was constructed in 1986. More than 700 died when the building collapsed. Construction consisted of nonductile CIP-RC beams supported by URM walls, with precast concrete floor planks. Figure 5 shows the collapsed floor precast planks. Note that the planks pulled away from the walls and are hanging and attached to the opposite walls. The collapsed URM walls and nonductile concrete beam is shown in Figure 6. A lab building adjacent to the collapsed school with similar construction did not collapse. This better performance was likely due to the orientation of its URM walls or better construction quality. Figure 7 shows the cracked walls.

Figure 5. Collapsed floor planks

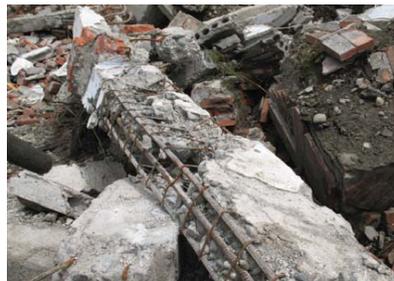
Figure 6. Collapse URM wall and concrete beam

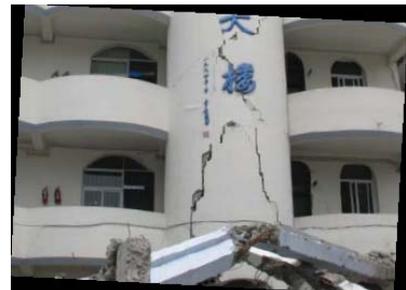
Figure 7. Shear cracks in masonry walls

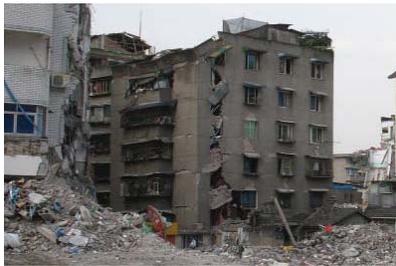
A wing at the Xingfu Hospital collapsed (Figure 12), resulting in 200 fatalities. This wing, constructed in 1996, had typical nonductile CIP-RC framing with URM walls and precast concrete floor planks. An adjacent wing, constructed in 2000, performed better and sustained moderate structural damage, shear-wall cracks, and nonstructural damage, dropped ceiling panels (Figure 13).

Figure 12. Collapsed wing

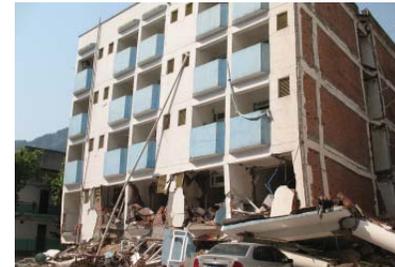
This five-story hospital was constructed in 1999. Construction consisted of nonductile CIP-RC framing and URM walls. The ground floor was designed as a parking garage. Hence, the URM bearing walls were terminated at the first floor, creating a bottom story with much smaller lateral stiffness. This soft story completely collapsed during the earthquake (Figure 14) and the upper floors dropped down one floor.

Figure 14. Soft story collapse

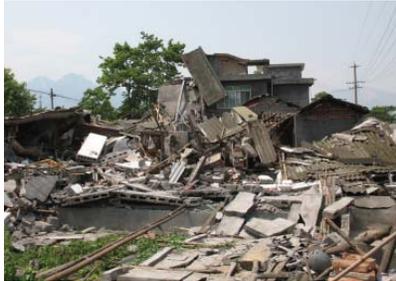
This small village of residential structures sustained severe damage and over 80% of the buildings collapsed (Figure 23). The structures were built of brick walls and wood-frame roofs with lightweight black roofing tiles.

Figure 23. Collapsed residential units

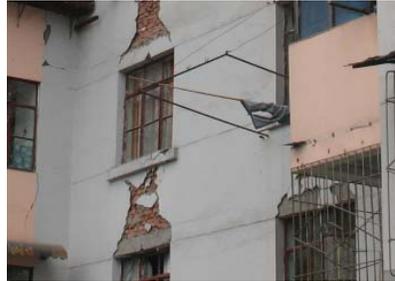
Several eight-story apartment buildings, constructed of URM bearing walls and concrete slabs, constitute a complex in the center of Hanwang township. Many diagonal shear cracks occurred in the walls between windows (Figure 24), but the buildings did not collapse due to the redundancy and lateral capacity provided by the network of interior walls.

Figure 24. Cracked URM walls

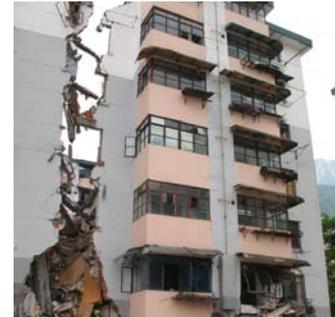
In this complex, a construction detail was used that called for connecting the adjacent residential units via a narrow corridor with a large number of windows. Hence, this portion of the complex, had little lateral stiffness or strength. The corridor URM walls for this complex failed, resulting in a portion of the building tilting and dropping by 3 m, and causing a vertical split in the corridor (Figure 25).

Figure 25. Vertical split and displaced apartment complex

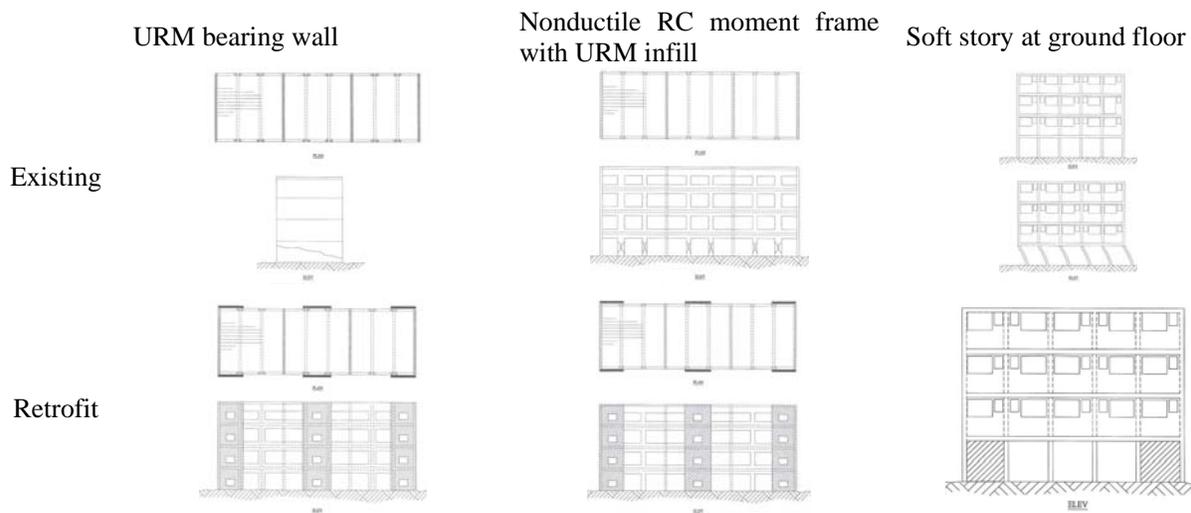
Figure 30. Proposed retrofit schematics

Nearly all the collapsed buildings had low strength, or stiffness, and ductility; little redundancy; questionable load path, and some undesirable seismic configuration (soft story, short columns, or irregularity). Cost-effective retrofit options are available to mitigate such deficiencies. Typical options are listed in Table 1 and schematically shown in Figure 30. Since schools, hospitals, and apartments can be classified as important buildings and high-density population areas, the presented options emphasize these buildings. While the basic ideas discussed here do not address substandard construction, retrofitting might have prevented the sudden and total collapse of many buildings and the subsequent loss of life. The retrofit options are intended to provide the basis life safety goal; that is to prevent collapse. Higher retrofit goals such as minimizing structural damage or immediate occupancy are also possible, albeit at a greater monetary cost.

Building Type	Deficiencies	Retrofit design
All	Lack of diaphragm action	Check strength and ductility of the RC ring beams. Reinforce and confine them as needed. Add ring beams at each floor if they are not present.
URM bearing wall	Lack of lateral capacity and ductility	Add full-height ductile, RC shear walls on the exterior of the building
		Apply engineered cementations concrete (ECC) to the exterior of the walls
		Place the structure atop of seismic isolators
Nonductile RC moment frame with URM infill	Inadequate joint capacity, lack of column confinement, captive columns	Add full height ductile RC shear walls on the exterior of the building
		Cut the connection between the partial height infill URM walls and concrete columns; Wrap columns using FRP; Add prestressing or confinement to joints to; Add shotcrete to the existing members
		Place the structure atop of seismic isolators
Soft story at ground floor	Lack of lateral stiffness and capacity at a floor	Add single-story ductile RC shear walls on the exterior of the building

Add single story steel braces on the exterior of the
		Add viscous or Visco-elastic dampers to the ground floor
