Views and Comments

Higher Performance Seismic Structures for Advanced Cities and Societies

Jiro Takagi^a, Akira Wada^b

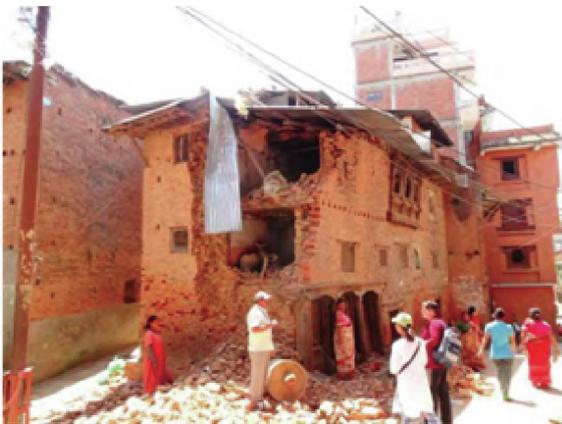
Fig. 1. Unreinforced masonry building damaged in the Gorkha earthquake in 2015 [3].

Structures are often constructed in a brittle manner due to a lack of knowledge or awareness of earthquake risk, and/or due to budget constraints. Fig. 1 shows an unreinforced masonry building that failed in the Gorkha earthquake in Nepal in 2015. Bricks became detached in unusual directions under strong shaking during this major earthquake, causing the building to fall apart. Similar damage has been observed in many other earthquakes including those in L'Aquila (Fig. 2), Haiti, Sichuan, Amatrice (Fig. 3), and Puebla. Masonry structures have been widely adopted in many regions in order to take advantage of their ease of construction, which allows bricks to be laid without the use of large construction machines. However, the strength of the connections between the bricks is typically insufficient to resist strong shaking during major earthquakes. Possible countermeasures include installing wooden frames or reinforcement (Fig. 4) and strengthening the mortar cement. Many of these buildings are non-engineered and have been constructed without the proper involvement of structural engineers. Although the seismic strength of such masonry buildings varies widely, and its assessment is difficult, greater involvement of structural engineers is needed.

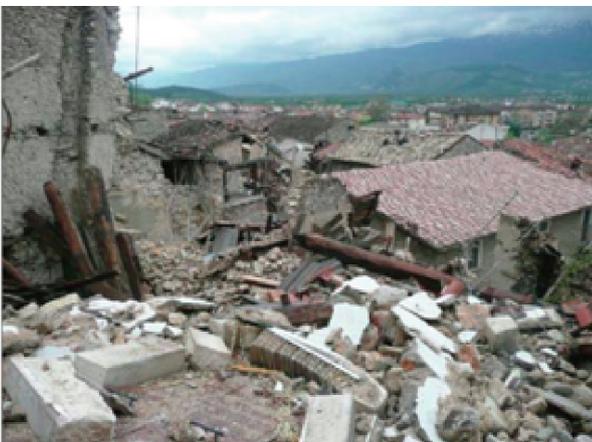
Fig. 2. Collapsed masonry buildings in the L'Aquila earthquake in 2009 [4].

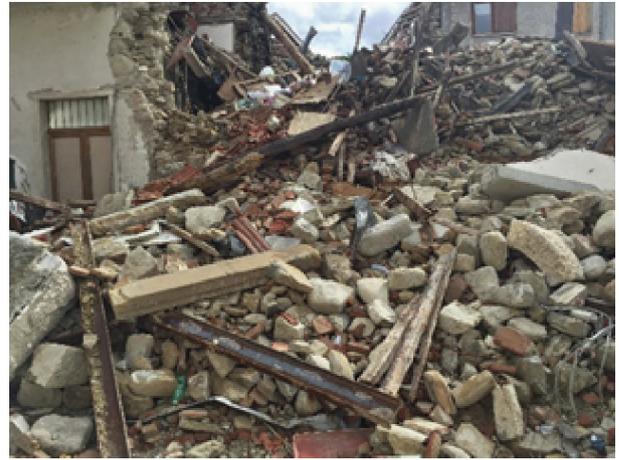
Fig. 3. Collapsed masonry buildings in the Amatrice earthquake in 2016.

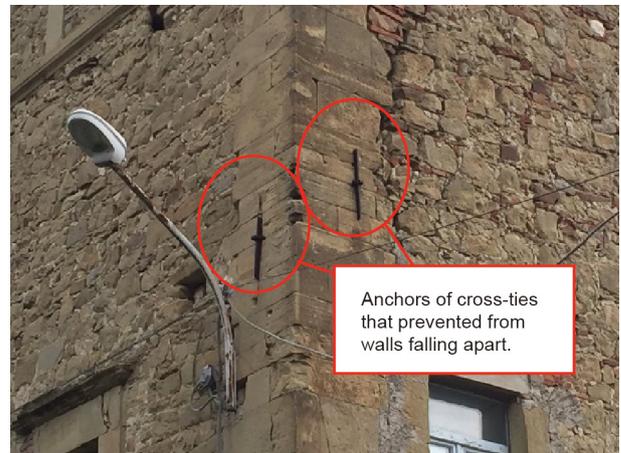
Fig. 4. Surviving masonry building with cross-tie reinforcement in the Amatrice earthquake.

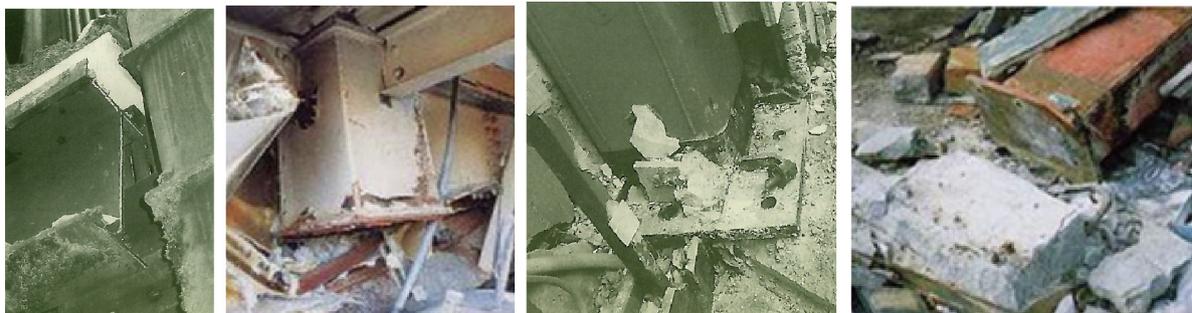
Fig. 7. Failure of steel structures in the Great Hanshin Earthquake [7].

Steel is a type of ductile construction material and steel structures can be ductile; however, inadequate detailing or construction may cause such structures to experience brittle failure under large earthquakes. Fig. 7 shows brittle failure in steel structures that occurred in the Great Hanshin Earthquake. The welding at beam-to-column connections had failed and anchor bolts had ruptured. Connection detail requirements were revised after this earthquake.

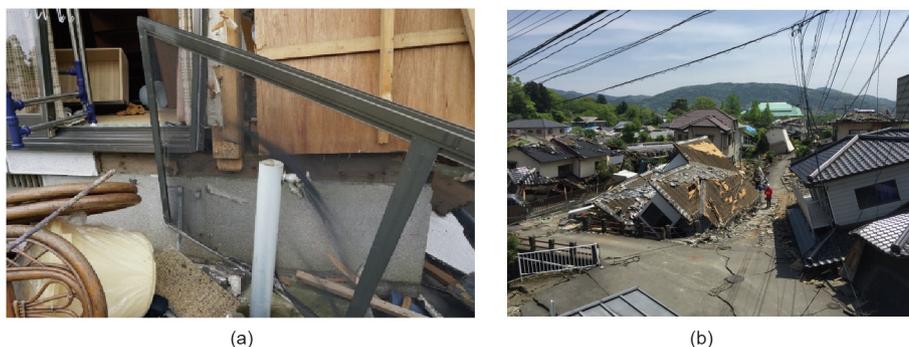
Fig. 9. Wooden houses in the Kumamoto earthquake in 2016. (a) Connection failure; (b) collapsed houses.

Most houses in Japan are wooden, and many of these old wooden houses are non-engineered. Fig. 8 shows a failure of connections between columns and beams. The collapse of wooden houses caused more than 90% of the casualties in the Great Hanshin Earthquake. More than 20 years later, the Kumamoto earthquake occurred in 2016. Fig. 9(a) shows a failure between a wooden column and the sill. As Figs. 8 and 9(a) show, certain aspects have not been improved over the last 20 years in the field of structural engineering. Connection failures still lead to the collapse of houses (Fig. 9(b)).

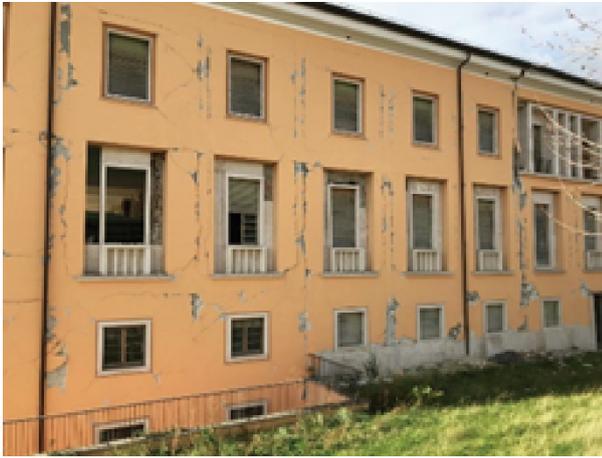
Fig. 12. A damaged building that did not collapse but remained unused after the Amatrice earthquake of 2016.

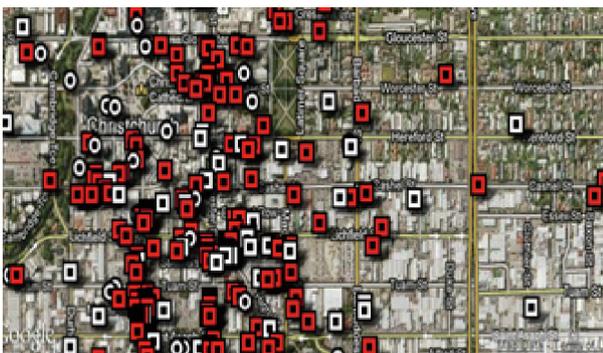
Fig. 13. Damaged buildings in the Christchurch earthquake of 2011; white and red squares indicate repaired and demolished buildings, respectively.

Although only two buildings completely collapsed in the Christchurch Earthquake in New Zealand in 2011, approximately 1700 out of 2400 buildings were demolished due to cracking or tilting. Fig. 13 illustrates the locations of the repaired and demolished buildings. It is notable that more buildings were demolished than repaired.
