PERFORMANCE OF SEISMICALLY ISOLATED BUILDINGS IN JAPAN
-Observed records and vibration perception by people in buildings with seismic isolation -

N. Kani,¹ M. Takayama² and A. Wada³

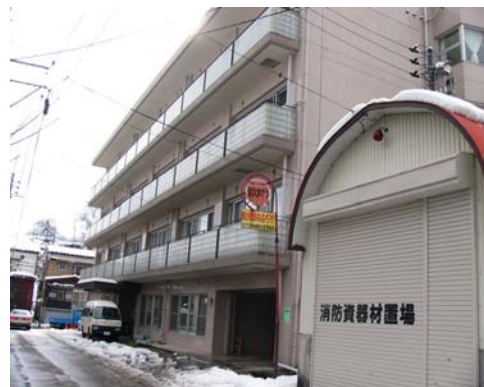
Photograph 2.2 Health care facility.

The building is RC structure with seismic isolation system (Photograph 2.2). The secretary general of the facility was not in the building at the time of the earthquake, but he did not notice anything different about the building after returning. Nothing fell from shelves, and there was no damage in the building. The next day this building had become a shelter for people from Ojiya hospital facilities which had been damaged. The transformation of seismic isolation layer was around 140mm from a skid trace of the slider with elastomer (Photograph 2.1). The effects of seismic isolation (reduction rate) were 1/4th according to the acceleration ratio of the base to the superstructure, by an installed seismograph.³⁾

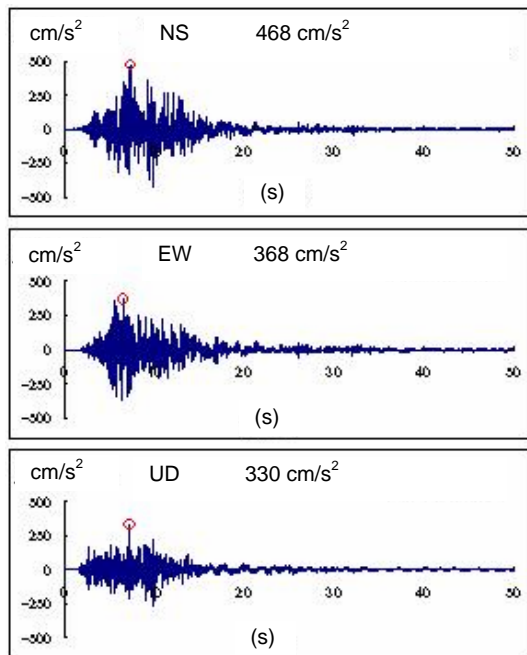
Figure 2.1 Record of acceleration.

In addition, the server rack of the computer system was attached to the access floor by screws only, in accordance to low response acceleration by adoption of seismic isolation system. The relative displacement of seismic layer in the earthquake was about 80 mm by orbiter, shown in Photograph 2.4. There was no damage. Figure 2.1 shows the records of acceleration at K-NET NIG017 Nagaoka, 2.8 km from this building.

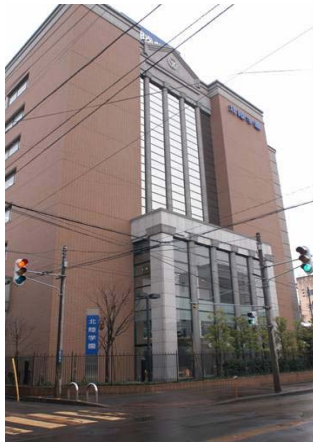
this building which they said felt like riding a boat (Photograph 2.5).

They are very satisfied with the seismic isolation system in their building. About 200 mm displacement of seismic isolation layer was measured shown as Figure 2.2. The effect of seismic isolation is shown as one-fourth reduction by an installed seismograph installed in the seismic isolation layer as shown in Figure 2.3, 2.4 and Table 2.2.⁵⁾

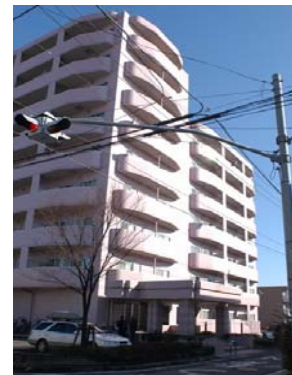
Photograph 2.6 Condominium.

The structure is a steel composite reinforced concrete building that is a condominium of fifty-three units in Niigata City, all of which are rented (Photograph 2.6).

Residents of two units replied that they were not aware that their building was installed with a seismic isolation system and they were surprised that other buildings had shaken so much.

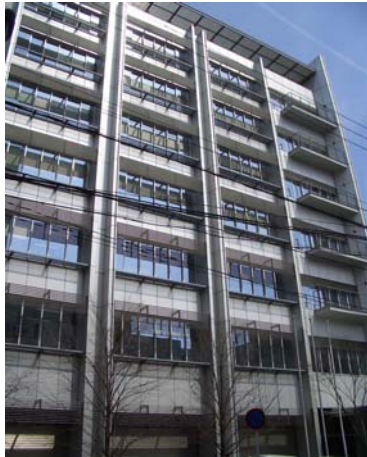
Photograph 3.1 Appearance of Building F.

The building is in the vicinity of the Kego Fault. Photograph 3.1 shows the appearance of the building after the earthquake. The entrance step was partially damaged because of insufficient vertical clearance in Photograph 3.2. Conventional structures suffered damages in this area. In addition, the orbit was traced on the iron plate at the corner of the service entrance of the building (Photograph 3.3).

The north and south component was greater than east-to-west. The maximum response displacement of the seismic isolation layer reached about 300 mm. A seismograph was installed in this building; acceleration indicated 203 gal of NS component at 65 m below ground, 489 gal at base, and 234 gal at the top floor of the building.

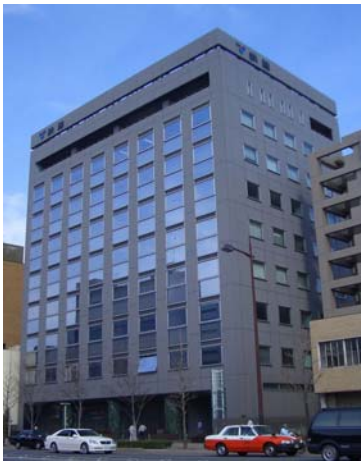
Photograph 3.4 Appearance of Building G.

Appearance of the building is shown in Photograph 3.4. The seismograph recorded a maximum acceleration in the base of 146 gal, but 71 gal at R floor and 45 gal at the first floor in the east-west direction.

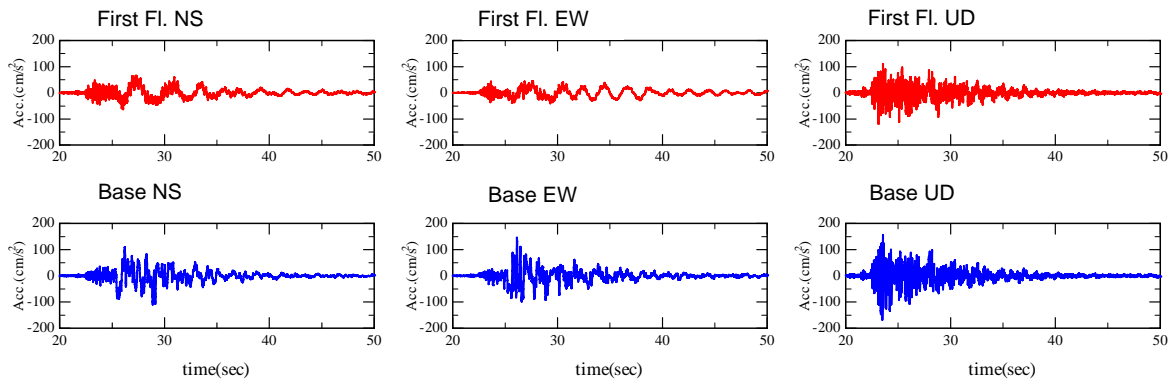
Figure 3.2 Record of acceleration.

Photograph 3.5 of the entrance shows that curb stones had moved about 150 mm to the south. It is a good correspondence that the observed displacement was 145 mm shown as Figure 3.1. Acceleration of the superstructure was reduced to one-half to one-third in Figure 3.2 and Table 3.2.

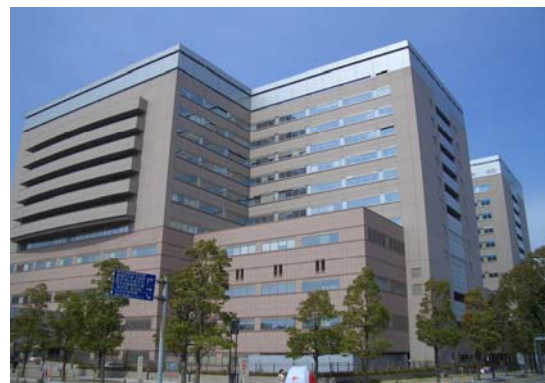
Photograph 3.6 Appearance of the hospital.

Photograph 3.6 shows the building appearance of a large-scale hospital. The entrance bridge of the south side of the hospital has expansion joints, but the handrail part of it did not work well as shown in Photograph 3.7.

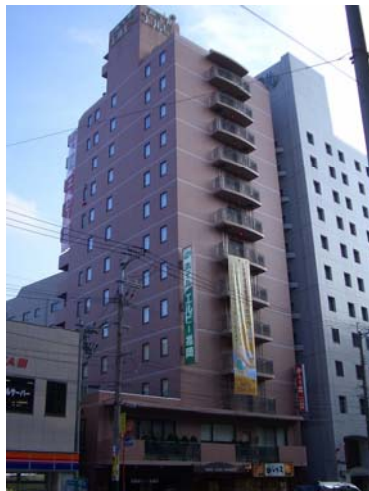
Photograph 3.9 Appearance of the hotel

This building is located about 600m from the fault. The building appearance after the earthquake is in Photograph 3.9. As for the trace in the seismic isolation layer, transformation was estimated at about 100 to 120 mm in the north-south direction, and about 70 mm east-to-west.
